Apartments and offices in Brussels BE

Vertical extension: replacement of the sloping roof by three levels of apartments.

IEA – SHC Task 37

Advanced Housing Renovation with Solar & Conservation

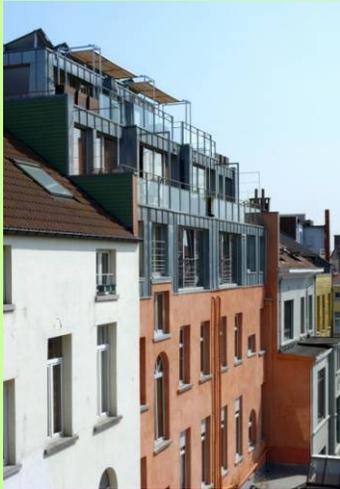
The new graded roof construction follows the silhouette of the old roof.

The terraced cross section follows the profile of the neighboring pitched roofs. The terraces are valuable space for relaxation and a small vegetable garden for each attica each floor.

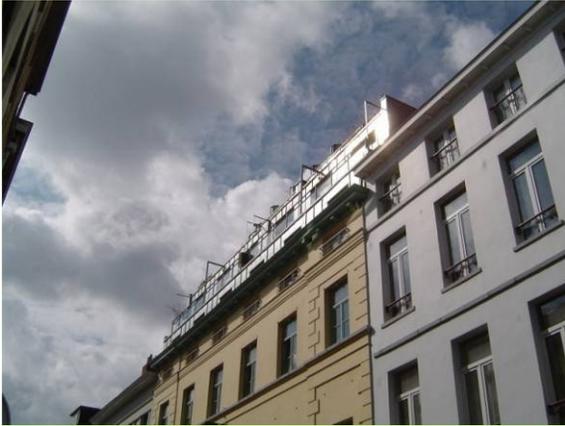
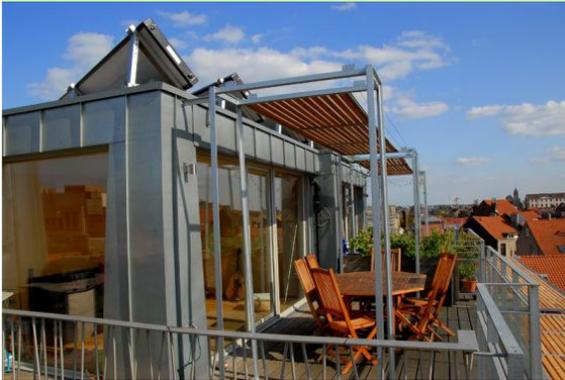
Southern terraces of the triplexes

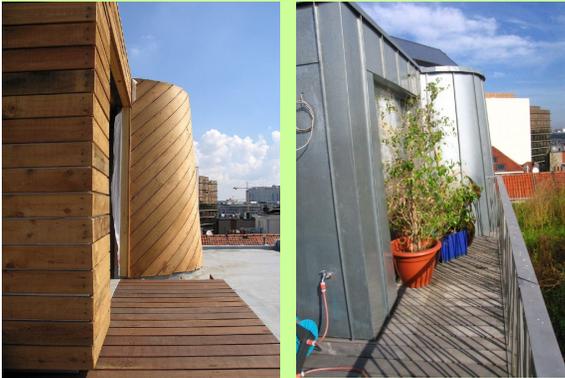
View on the terraces and the staircase during construction and after finishing

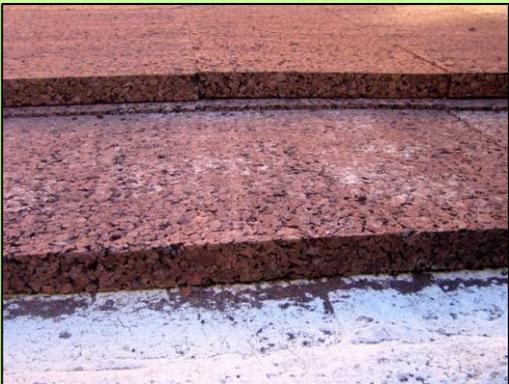
Natural cork insulation

EPDM light grey	
Cork insulation panel	200 mm
Cellulose insulation + rafter	200 mm
Variable internal air barrier	- mm
Battens	35 mm
Plasterboard	12 mm
Total	447 mm

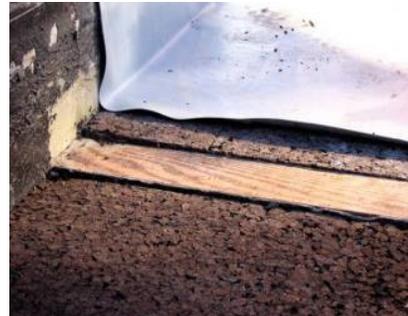
Detail of the EPDM liner over the cork insulation

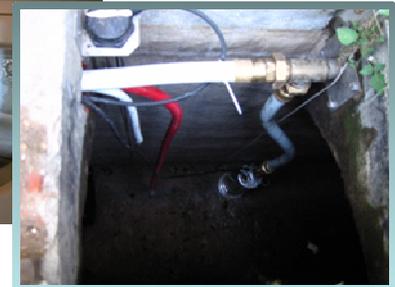
Re-activated water tank with pump.

The question of water treatment was answered in this project in several ways. The existing water tank was reused, a common clothes washing room was provided for all the tenants and the washing machine are supplied with solar hot water. The roofs terraces are used for vegetable gardens accessible from the apartments. The lower building of the annex has a green roof. The courtyard, with a few parking spaces, has a permeable covering and is surrounded by flowerbeds.

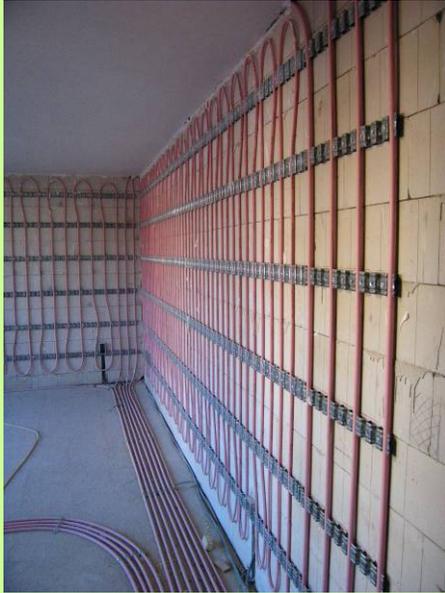
Silicate block wall and surface heating tubing.

The surface heating system circulates ‘hot’ water in the walls and the floors. The large surface area and good insulation allow it to operate at very low temperatures. In response to an external sensor, the surface temperature varies between 25° and 35° C.

- Clay plaster costs the same as a standard plaster but has better thermal and moisture inertia.
- Silicate blocks do not cost much more than standard hollow bricks, but their thermal inertia is better and they are glued rather than mortared. This is faster and hence saves on labor costs.

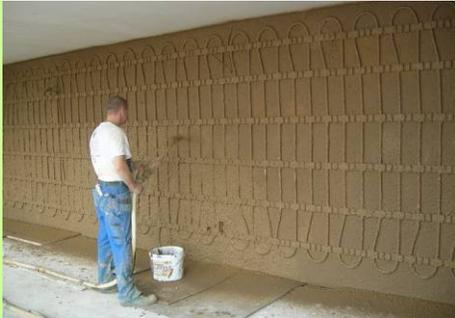
Applying the clay plaster

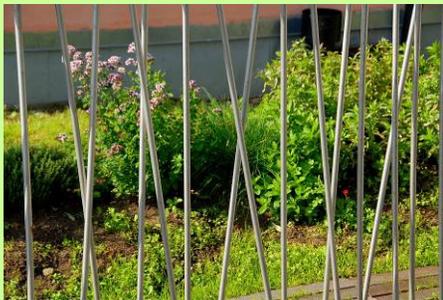
Small gardens on the new graded roof
